DEVELOPMENT OF A METALLIC BELLOWS EXPULSION DEVICE FOR FLUORINE SERVICE

MARTIN MARIETTA CORPORATION

CONTRACT NAS3-12053

FINAL REPORT

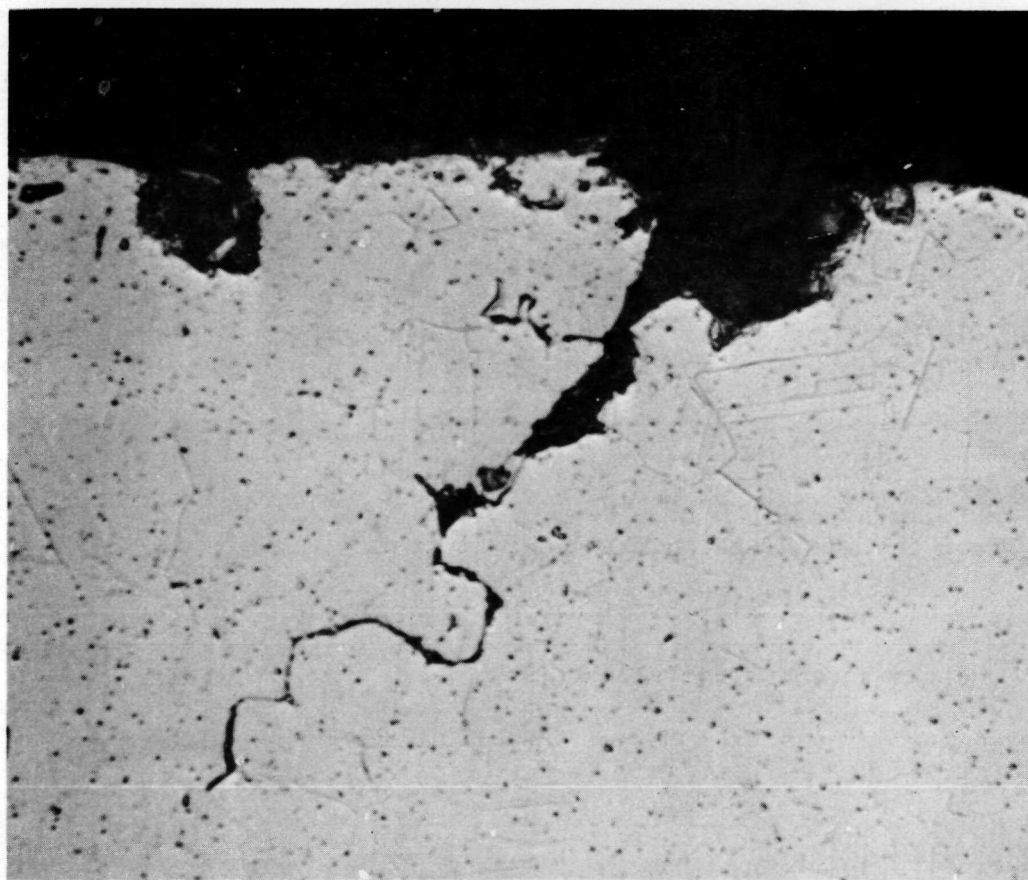
Figure 16 Crack in Bellows Adjacent to Weld Bead,
Bellows Assembly 2

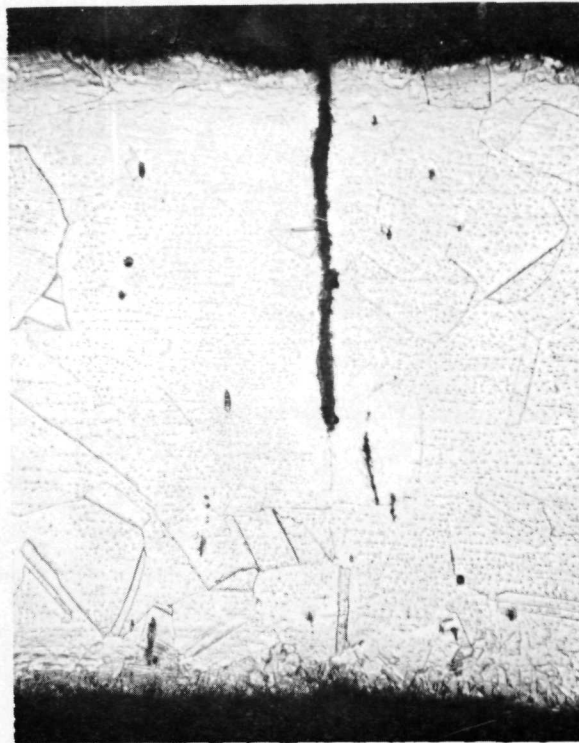
Figure 17 Seam in Flange, Bellows Assembly 4

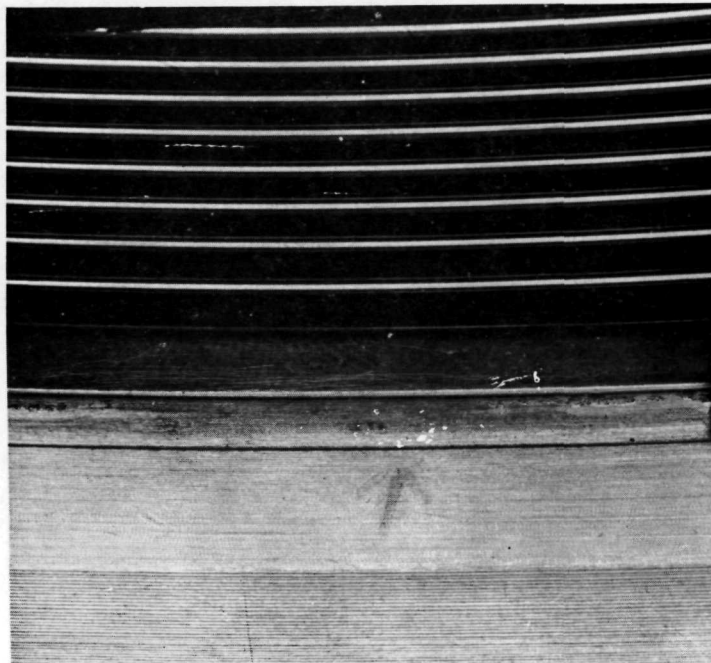
Figure 18 Unacceptable Guide Ring Weld, Bellows Assembly 5

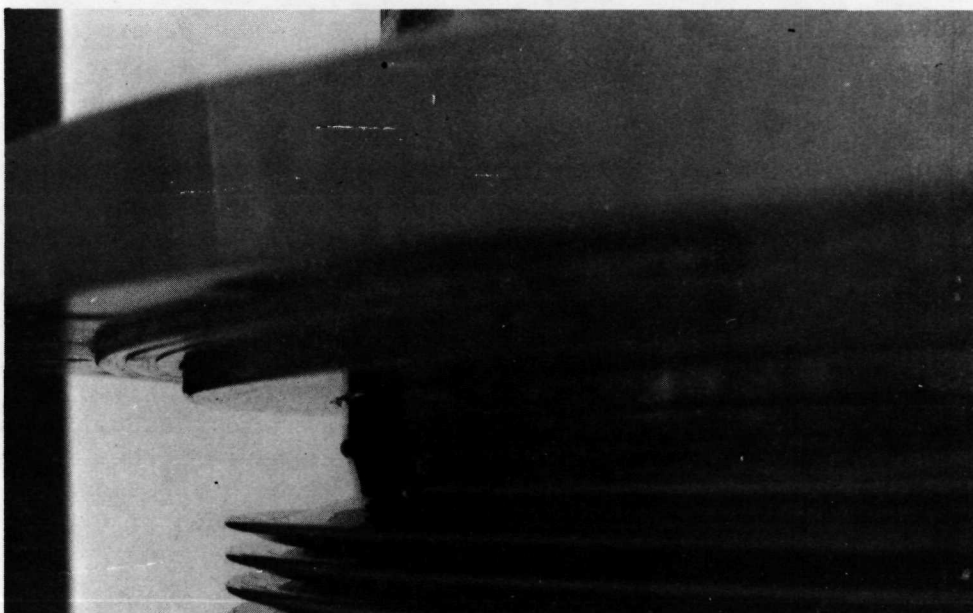
Figure 24 Closeup Showing Distorted Bellows Neck

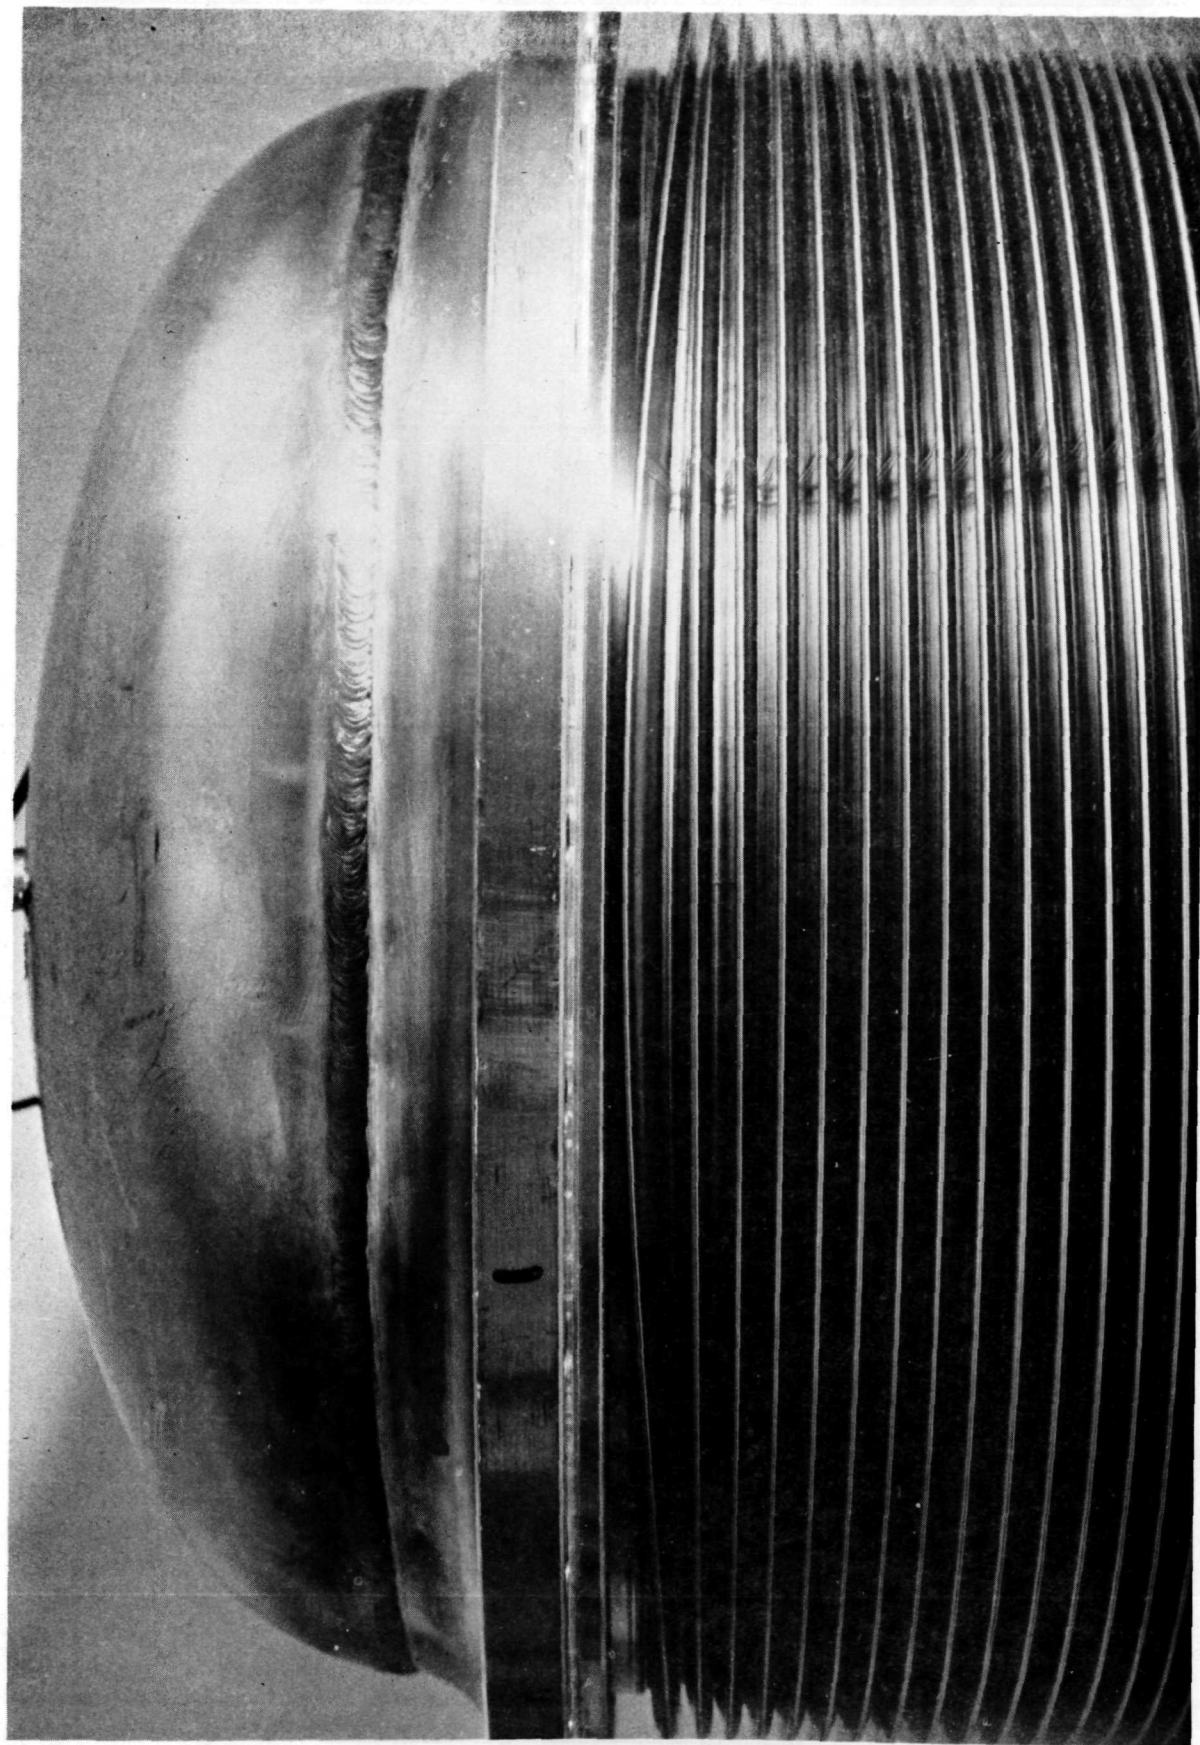
Figure 41 Distorted Convolution at Flange End

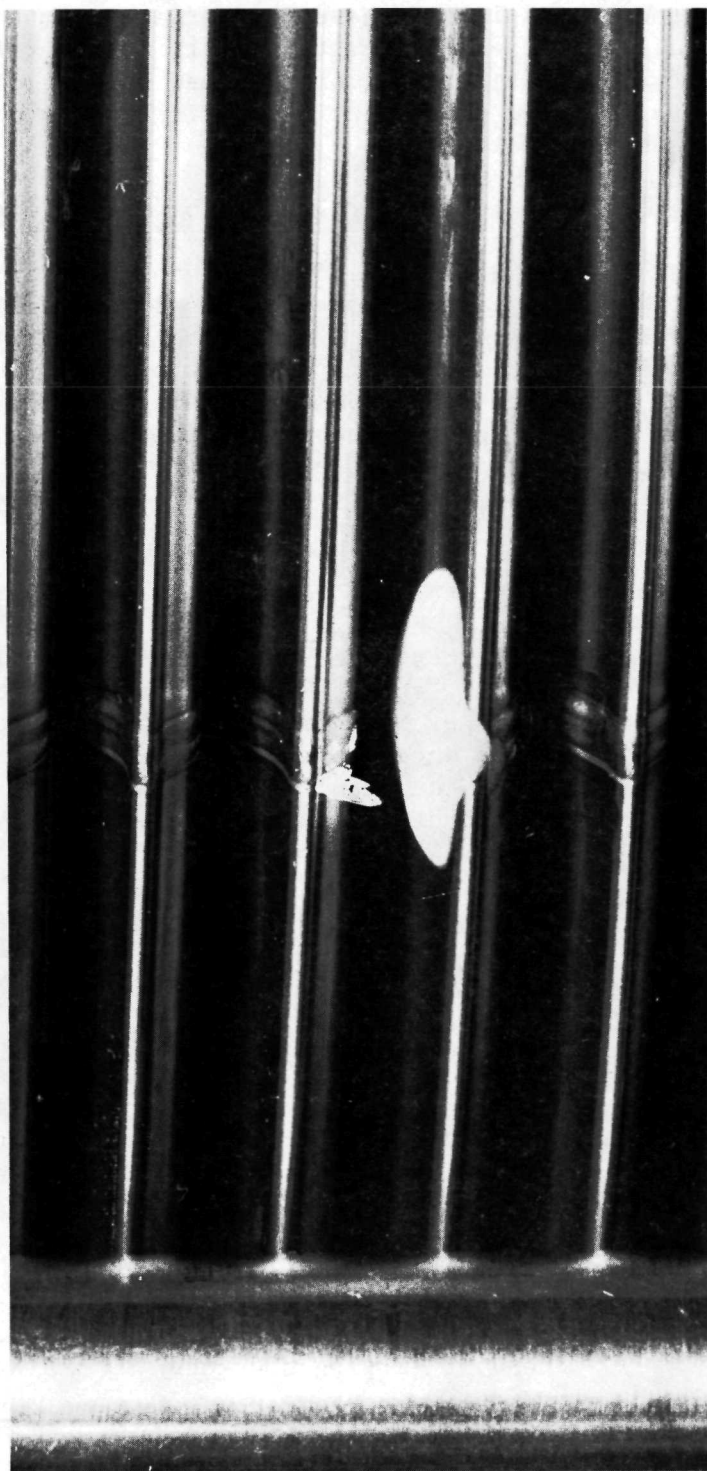
Figure 50 Cluster of Bubbles from Crack in Bellows

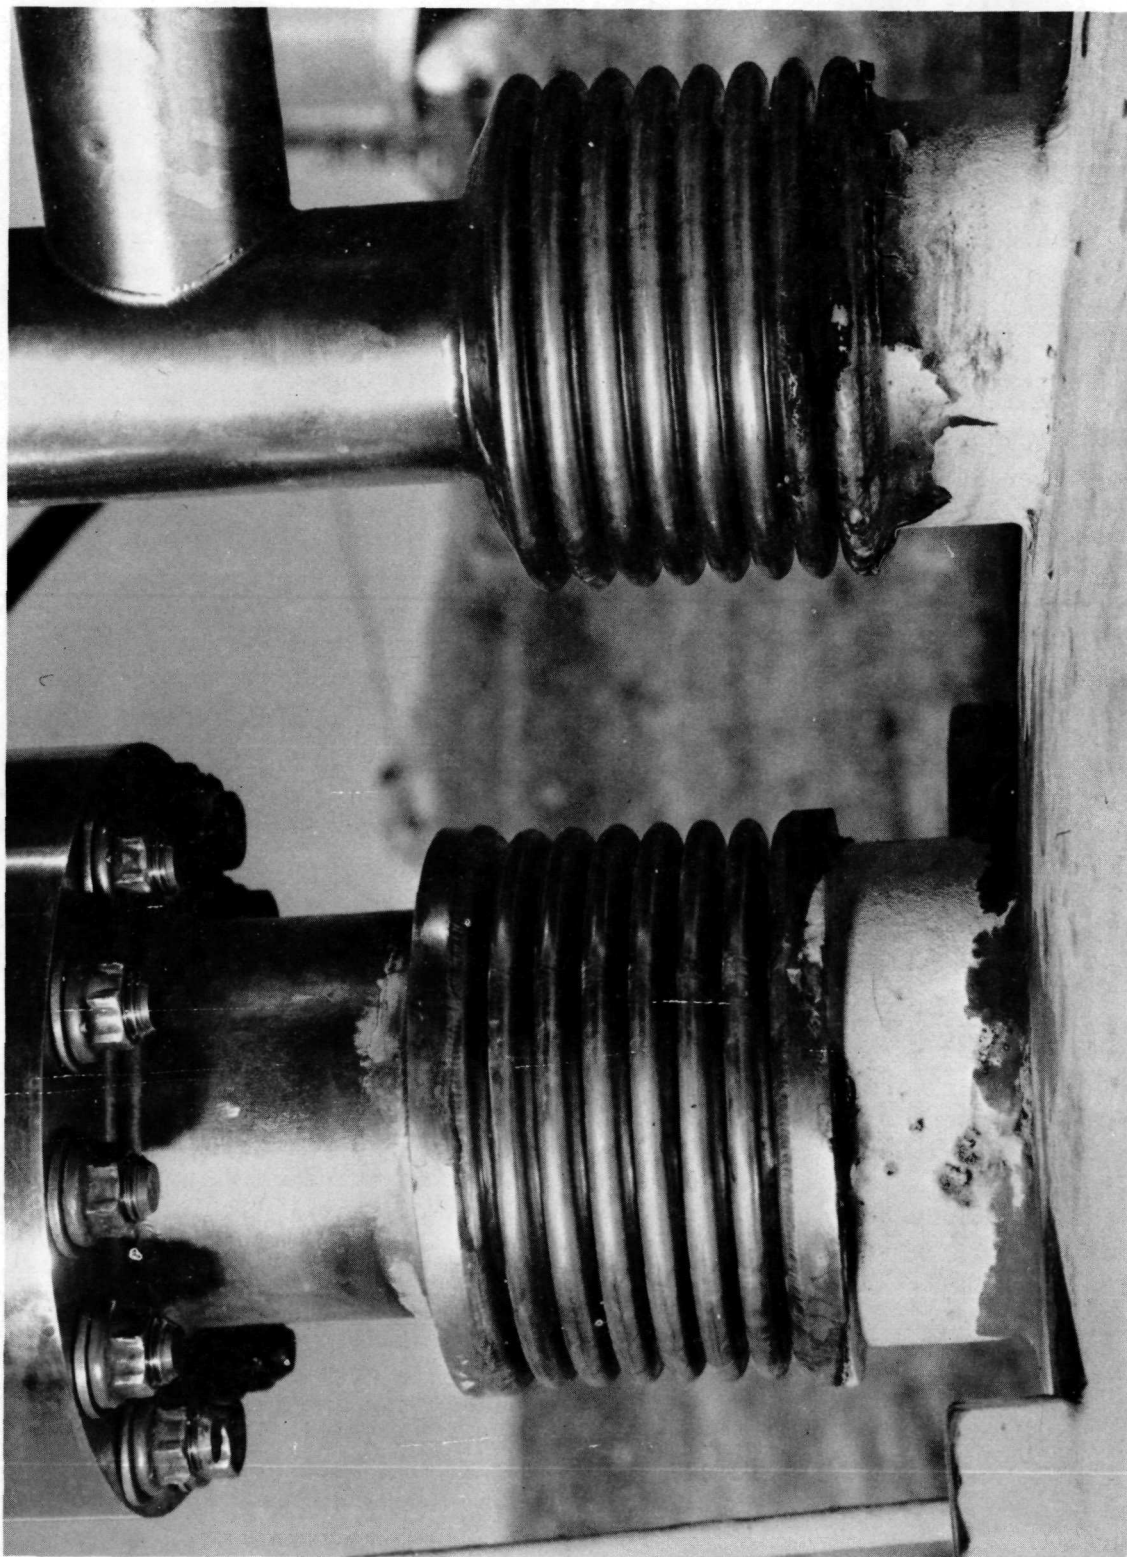
The following morning the dewar was carefully inspected for evidence of damage. The lower convolutions of outflow line expansion bellows were discolored as a result of burned paint, but there was no evidence of actual damage (fig. 56). Finally, the outflow valve was dismantled by removing the four bolts that hold the body and bonnet of the valve together. It was evident that one of the copper gaskets that seals the replaceable seat in the valve had been leaking slightly. The gasket was not actually damaged, but the surface was discolored in the vicinity of the leak. It was concluded that the tie bolts had loosened slightly as a result of temperature cycling, finally permitting the gasket to leak when the dewar was pressurized to a higher pressure level. The small amount of fluorine that leaked past the gasket then dripped down the line and onto the top of the dewar, reacting with the paint to produce considerable smoke and the crackling noises that had been heard. The system failure was of such a minor nature that no damage was done to any of the test hardware.

Figure 56 Expansion Bellows on Fluorine Dewar

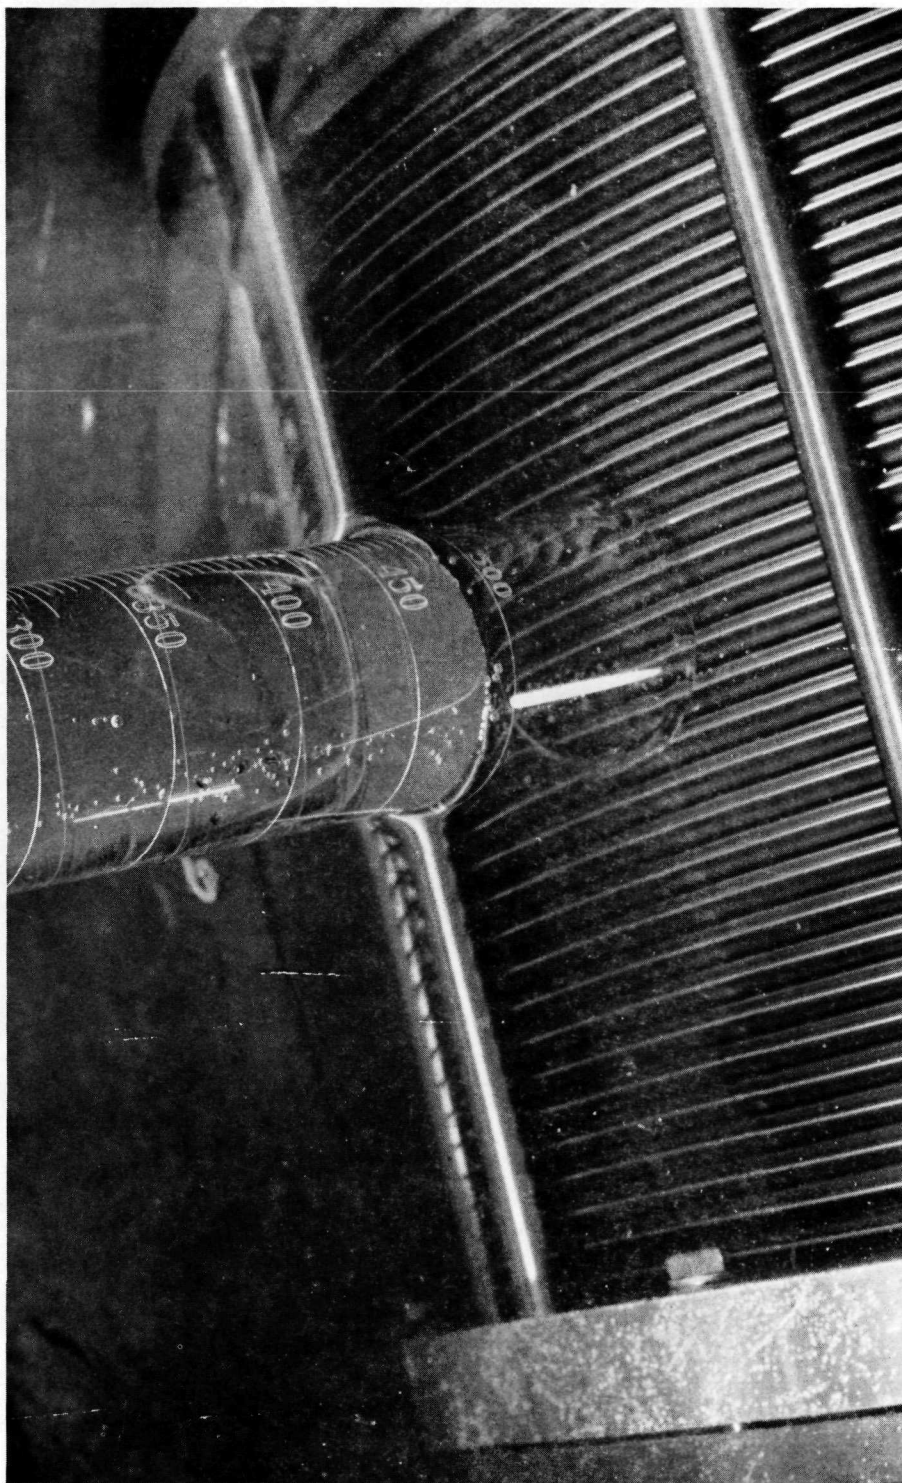
Figure 67 Bellows Cracks Undergoing Leak Check

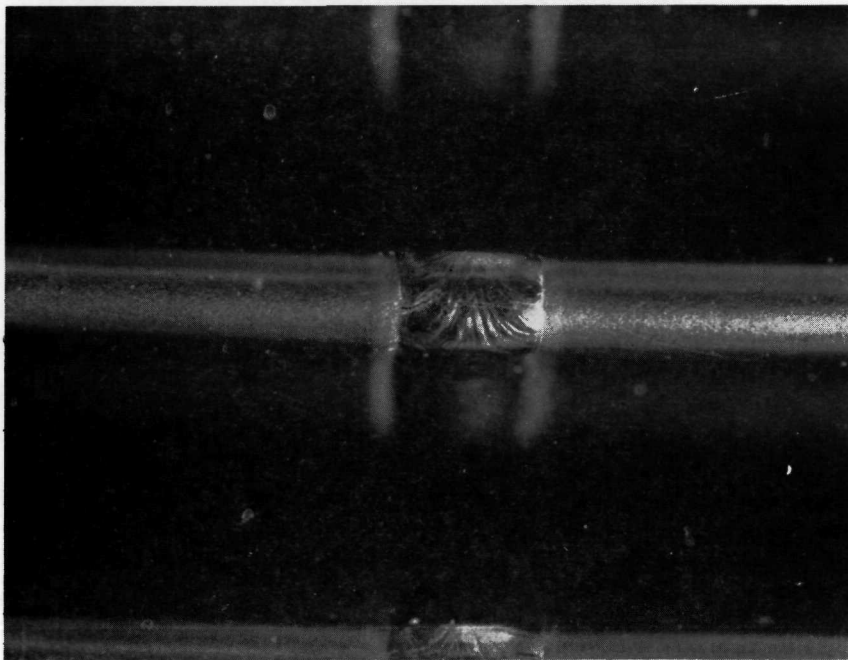
Figure 68 Typical Crack in Bellows Convolution

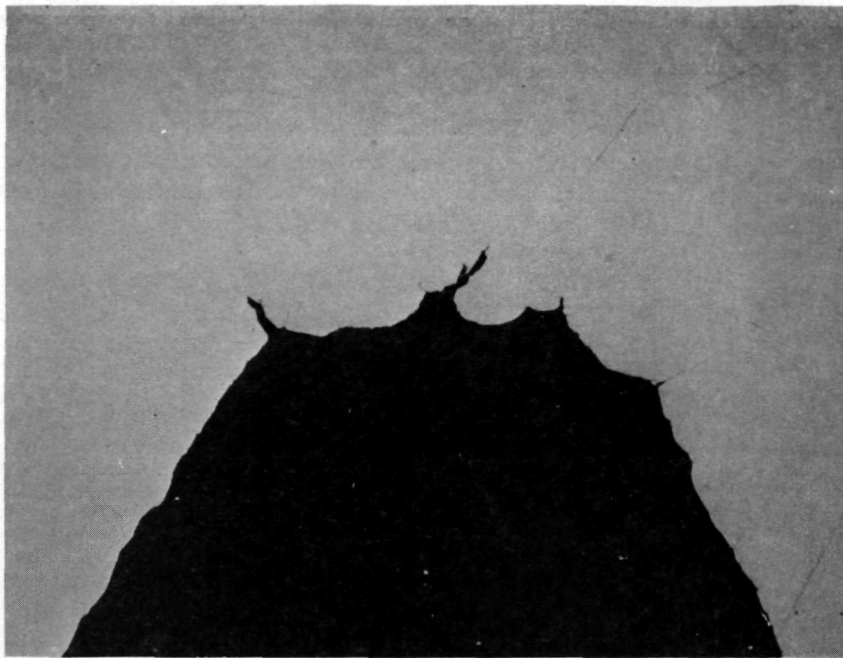
Figure 69 Typical Initiator Cracks (Unused Bellows)

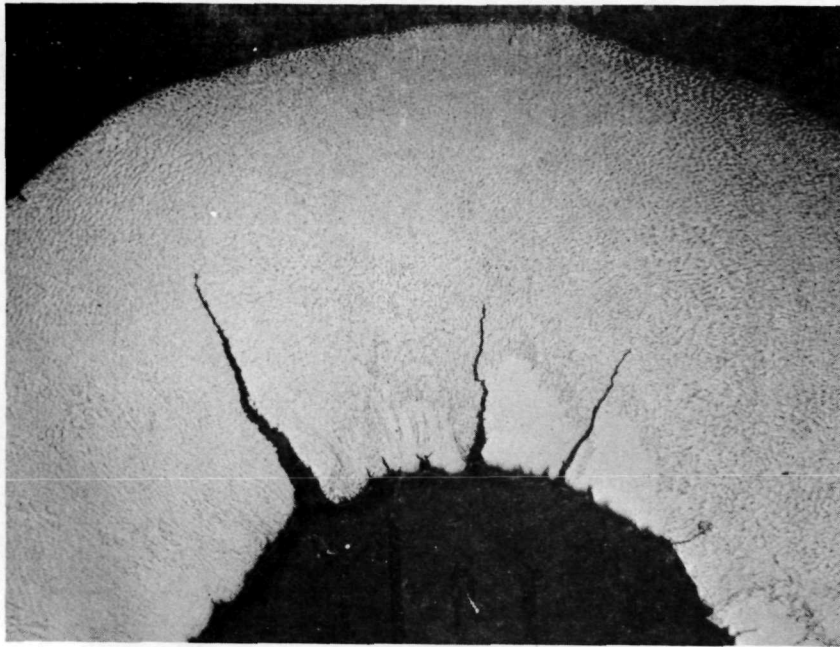
Figure 71 Typical Cracks, Bellows 5

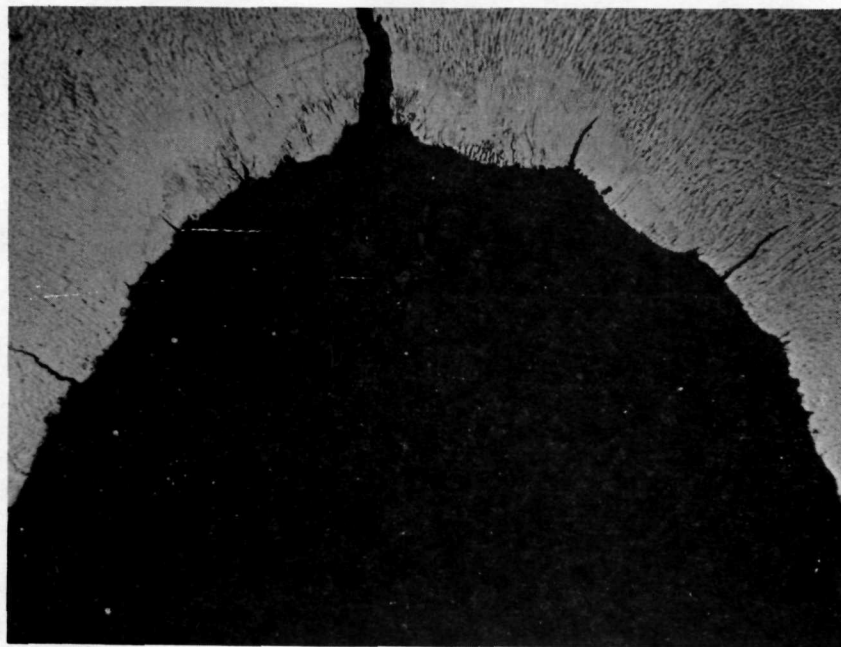
Figure 72 Additional Cracks, Bellows 5

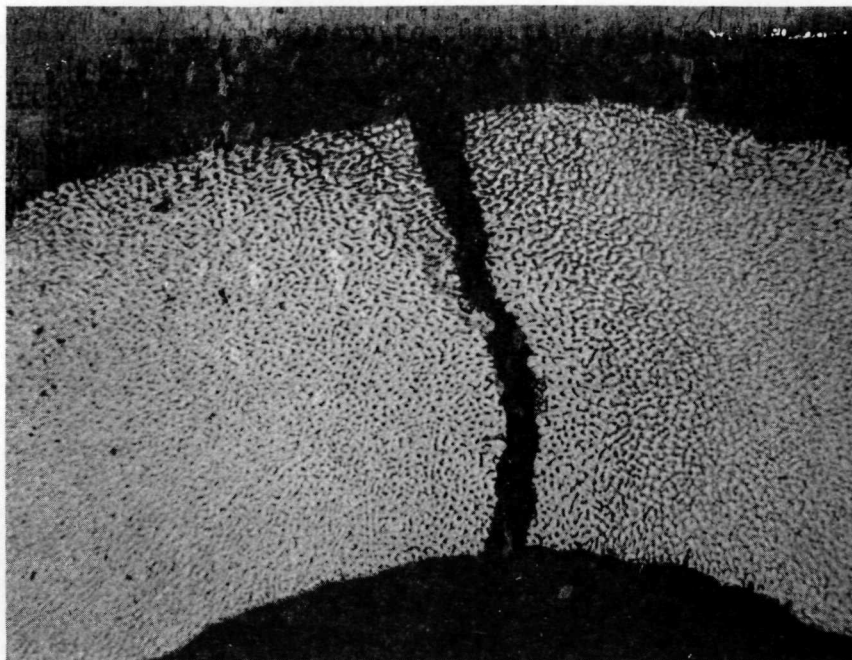
Figure 73 Crack through Convolution 18,
Bellows 5

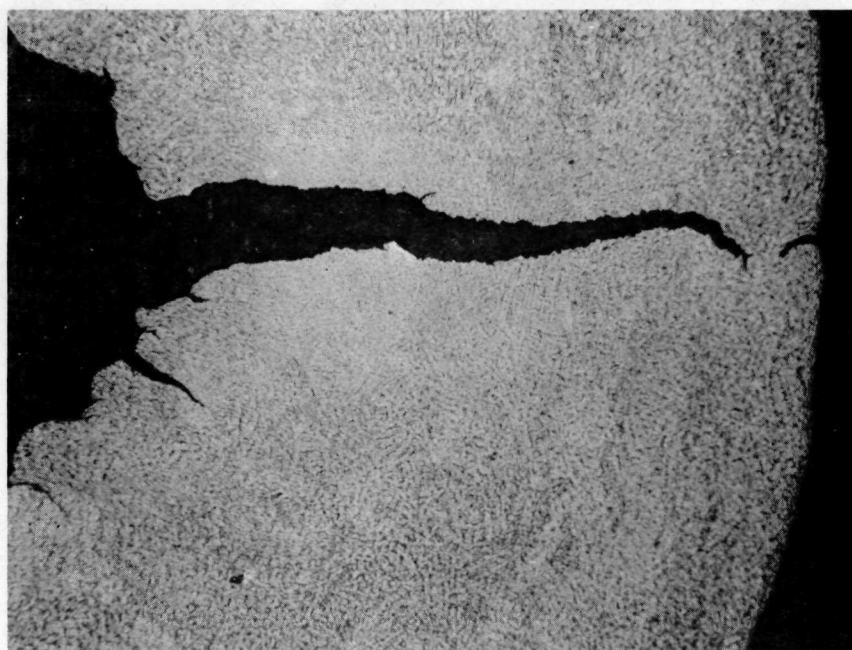
Figure 74 Crack in Convolution 20,
Bellows 8

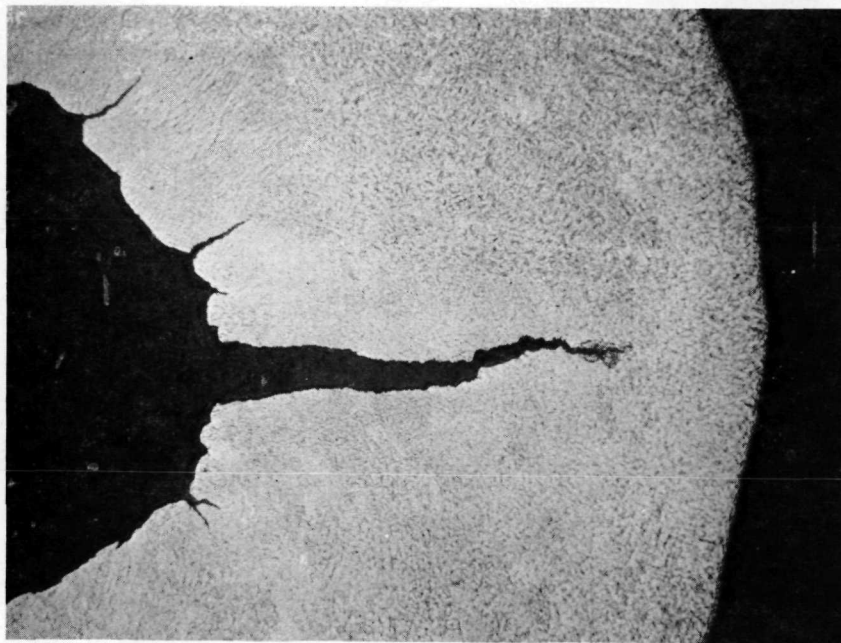
Figure 75 Crack in Convolution 21,
Bellows 8

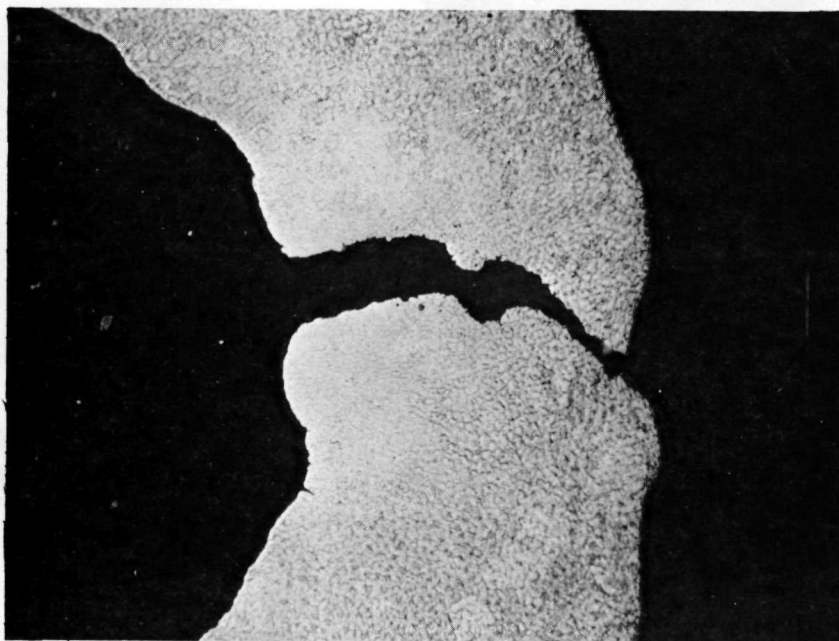
Figure 76 Crack through Convolution 22,
Bellows 8

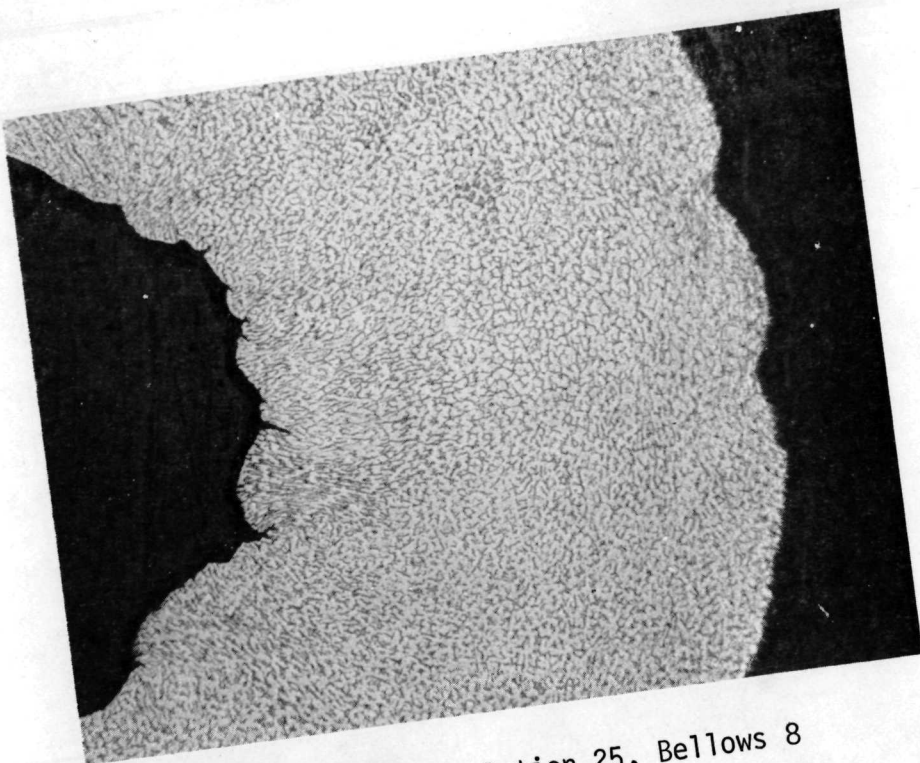
Convolution 25 is shown in figure 77, evidently a case where no significant crack propagation has occurred. This is consistent with the results obtained from the leak check.

Figure 77 Convolution 25, Bellows 8

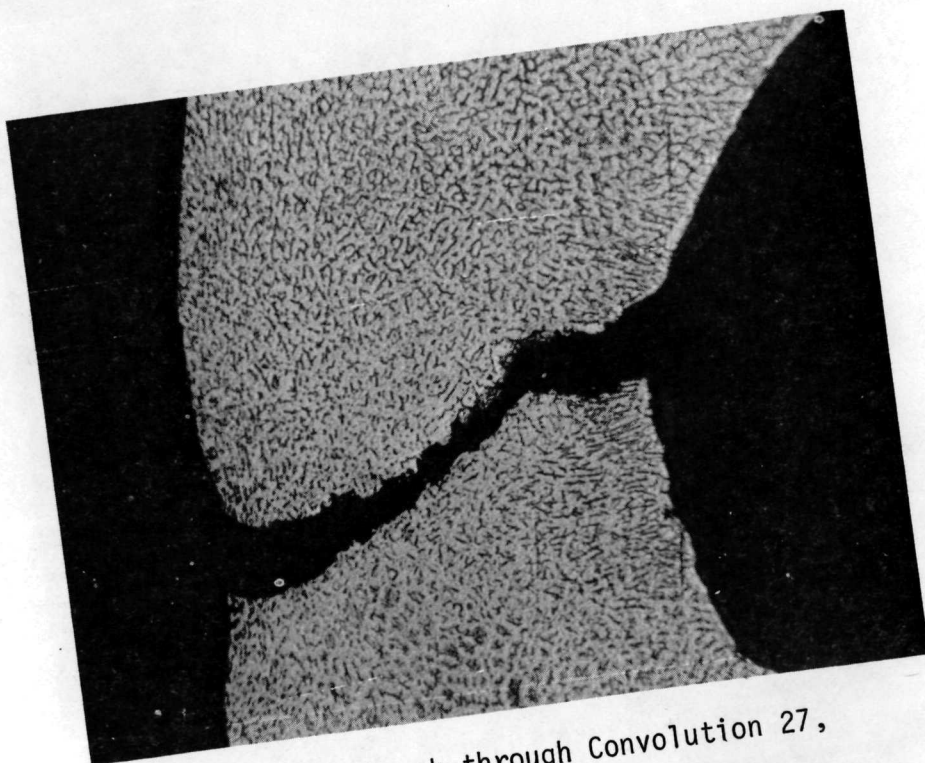
Figure 78 Crack through Convolution 27,
Bellows 8
